DYNAMIC SCIENCE, INC.
In-Depth Crash Investigation

Contract DTNH22-94-D-27058
Case DSI-96-AB-09

DYNAMIC SCIENCE, INC.
CRASH INVESTIGATION
CASE NUMBER: DS9609

This case was initiated in response to a report of airbag-related serious head injuries to a child in the right front passenger seat.

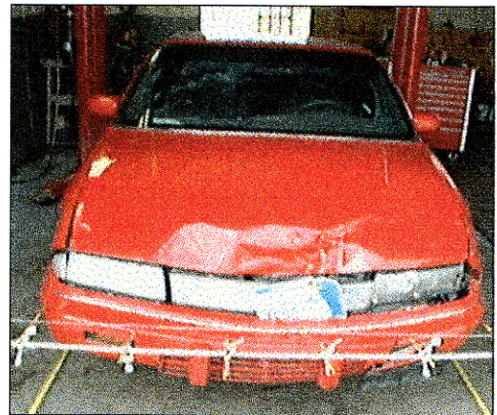
Figure 1. Vehicle 1, 1995 Pontiac Grand Prix

As Vehicle 1 approached the intersection, traffic in the adjacent two lanes was stopped. There was a break in traffic for those cars west of the intersection and east of the intersection and they allowed Vehicle 2 to begin his left hand turn. The driver of Vehicle 1 indicated that she saw Vehicle 2 enter the lane and braked. As Vehicle 2 entered the southernmost travel lane it was struck in the right front by the left front of Vehicle 1. Both airbags in Vehicle 1 deployed at this time. The computed delta V was 8 MPH, while the maximum possible delta V was determined to be 13 MPH (based on data from the on-board diagnostic module).
